STATE OF MICHIGAN
DEPARTMENT OF ENVIRONMENTAL QUALITY
LANSING

August 20, 2009

SUBJECT: G&H Landfill Superfund Site, Review of January – July 2008 Report

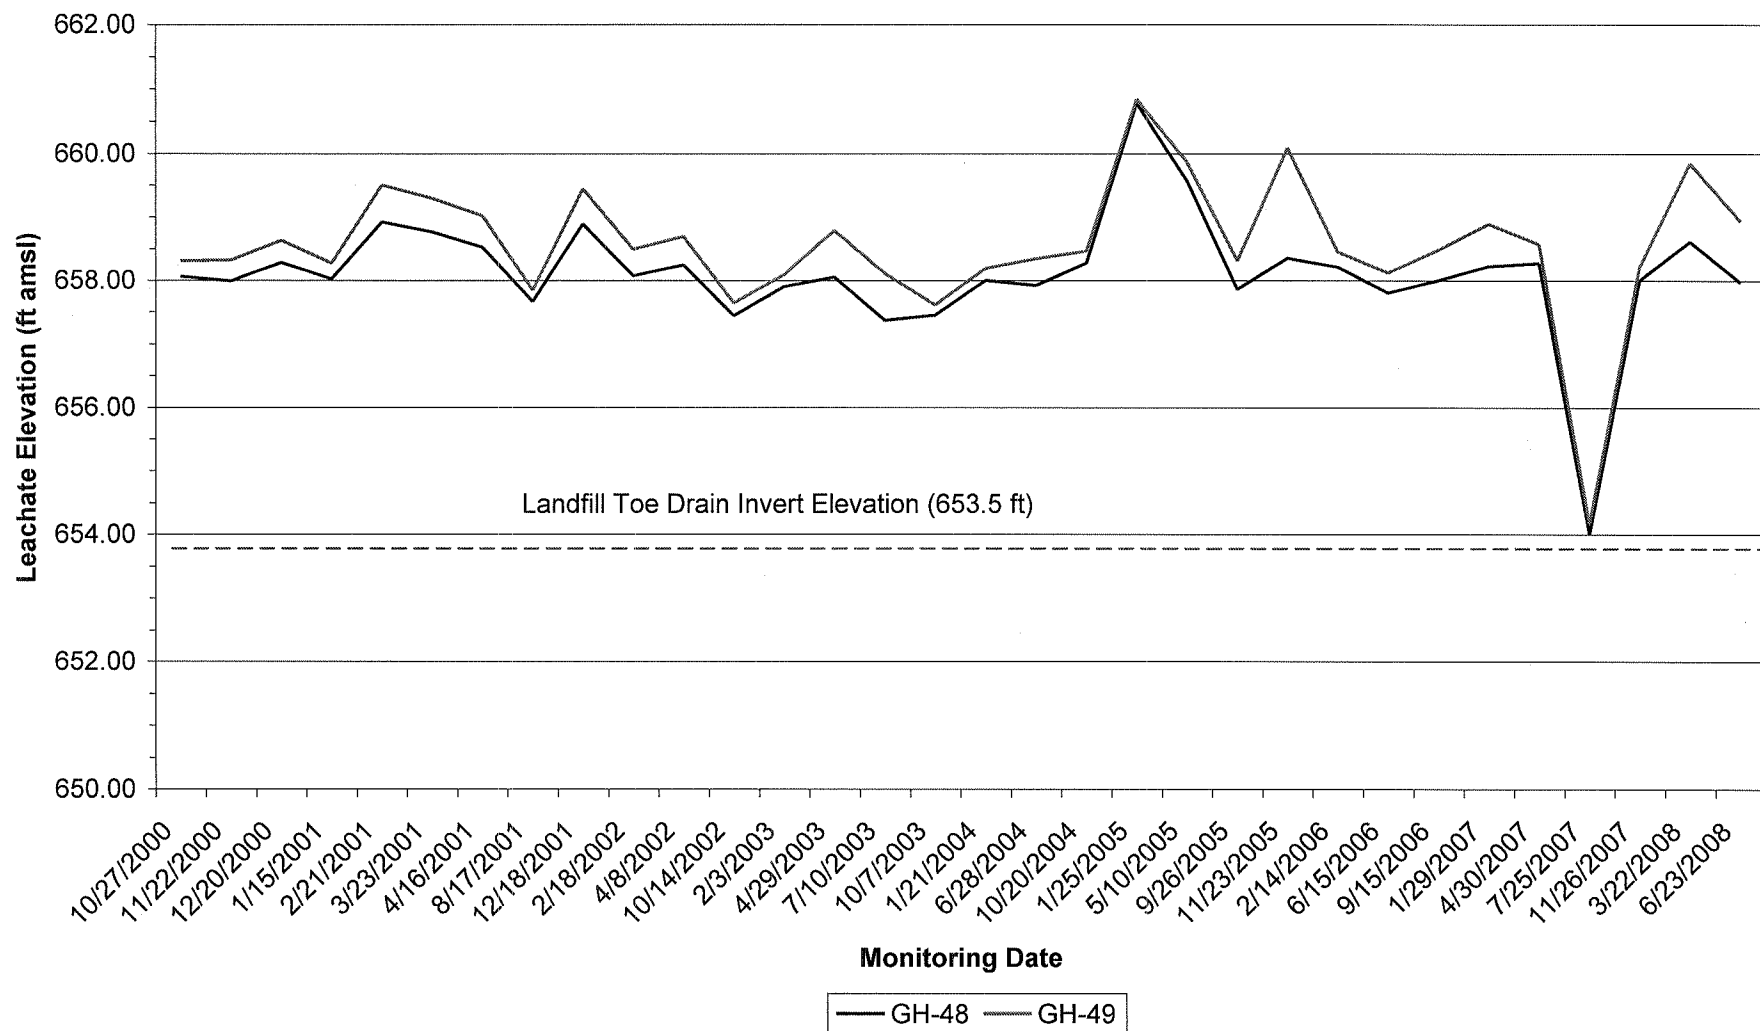
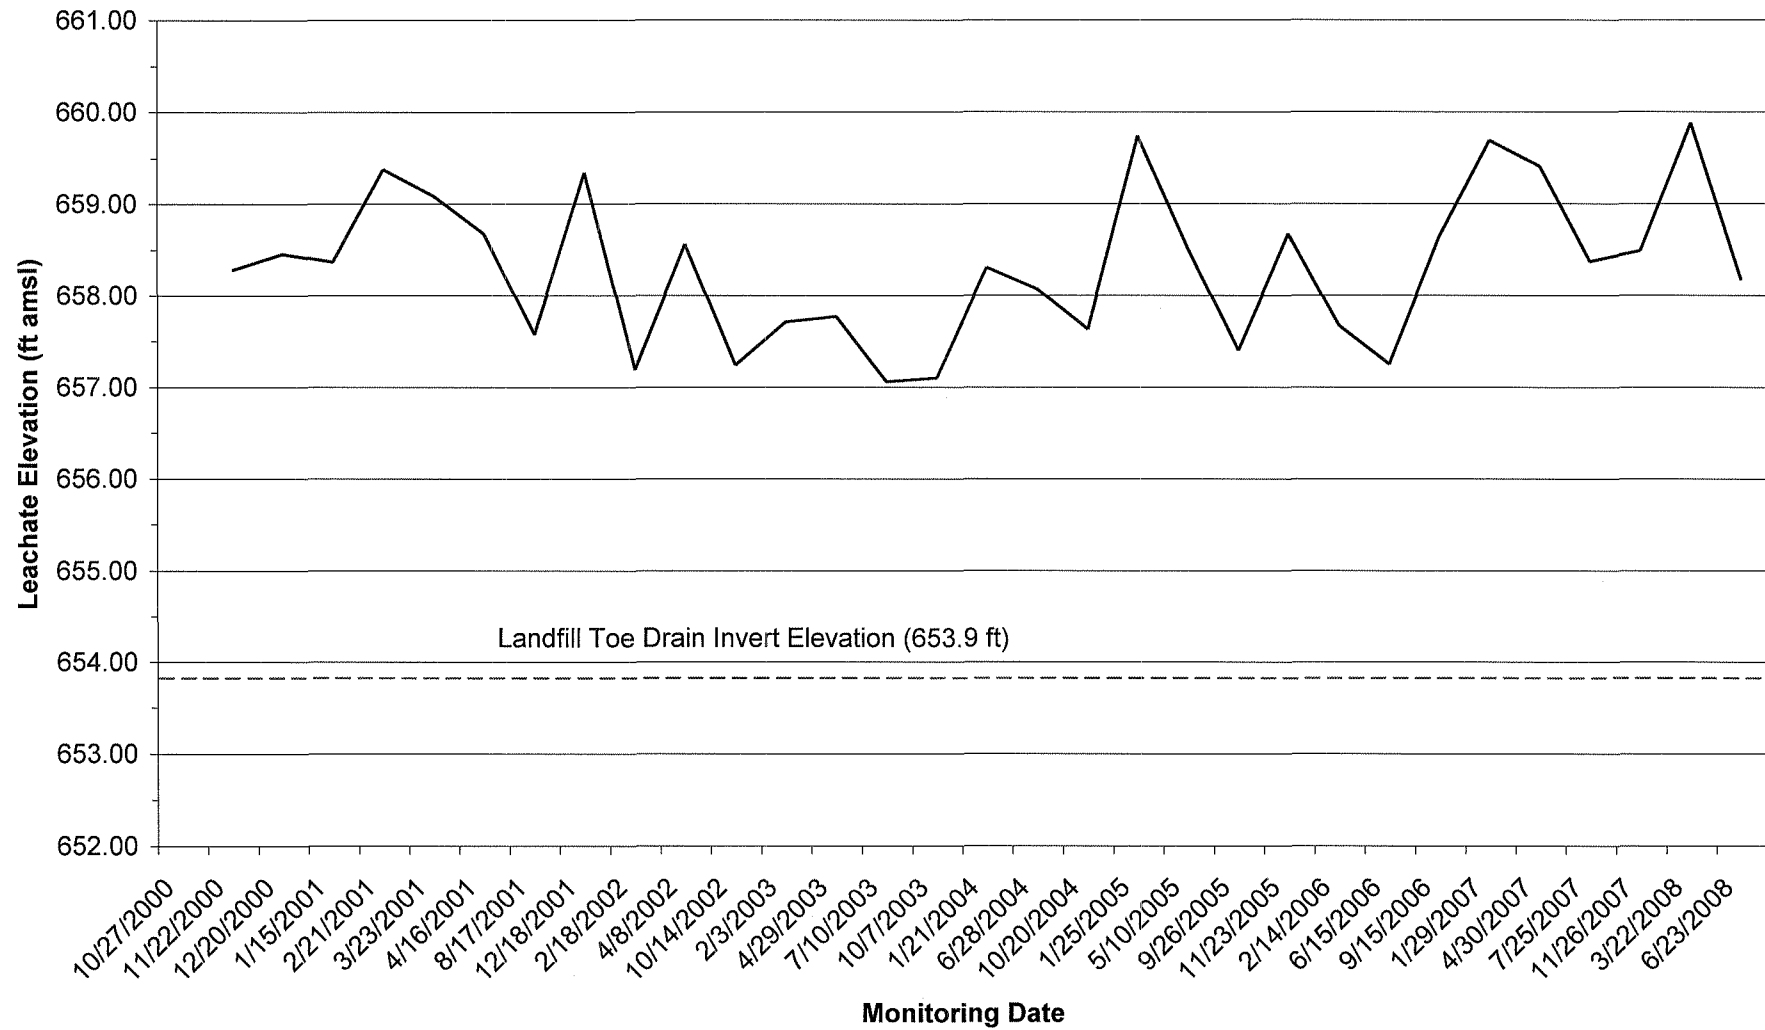
The OMP indicates that the pipe and media drain located along the west side of Phase III is designed to dewater the Phase III slope and intercept groundwater/leachate to prevent off-site migration. Additionally, the OMP indicates the pipe and media drain will be operated to maintain a dewatered condition. The MDEQ evaluated the water levels measured at GH-48, GH-49, and GW-10 over time with the toe drain collection pipe invert¹ elevation of the 6-inch HDPE collection pipe. The following is shown on Charts 18 and 19 (Attachment B):

- Water levels have significantly exceeded the toe drain collection pipe invert of the collection system throughout the past 8 years of operation; and
- June 23, 2008, water levels ranged from 4.27 feet at GW-10 to 5.44 feet at GH-49 above the toe drain collection pipe invert.

As indicated from Charts 18 and 19, the Phase III collection system has not achieved the performance objective of a dewatered condition and likely is not providing hydraulic containment of the leachate and contaminated groundwater migrating from Phase III.

- Evaluate the performance of the Phase III leachate collection system and execute contingency plans to achieve hydraulic containment at the Phase III landfill toe as required in the SOW;
